**Showcasing Water Innovation  
IMAX  
Fall 2013 Monitoring Update**

**Monitoring Progress**

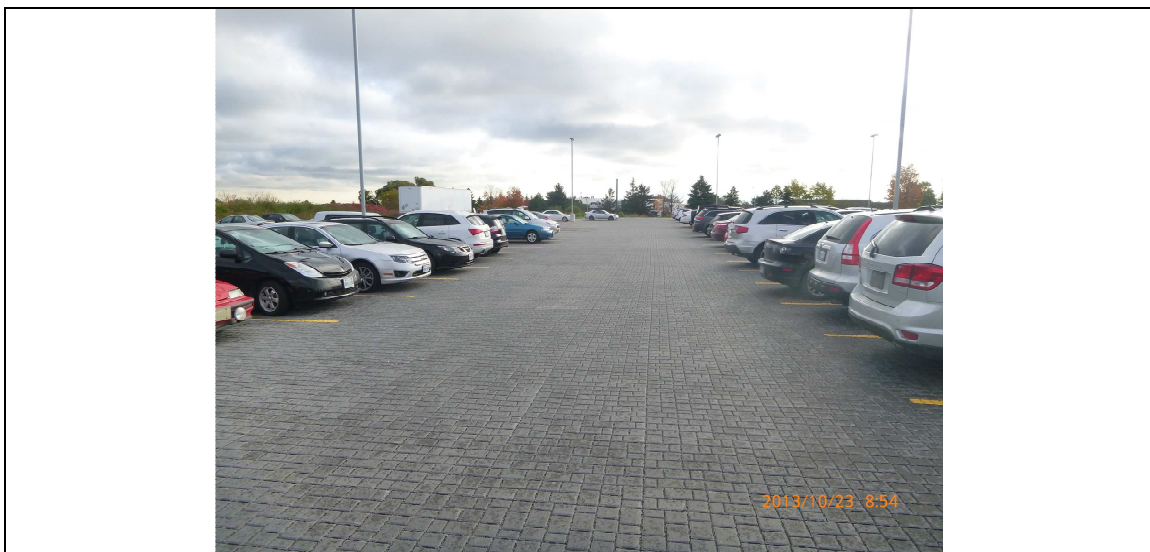
**Fall 2013 – IMAX Permeable Pavement Parking Lot**

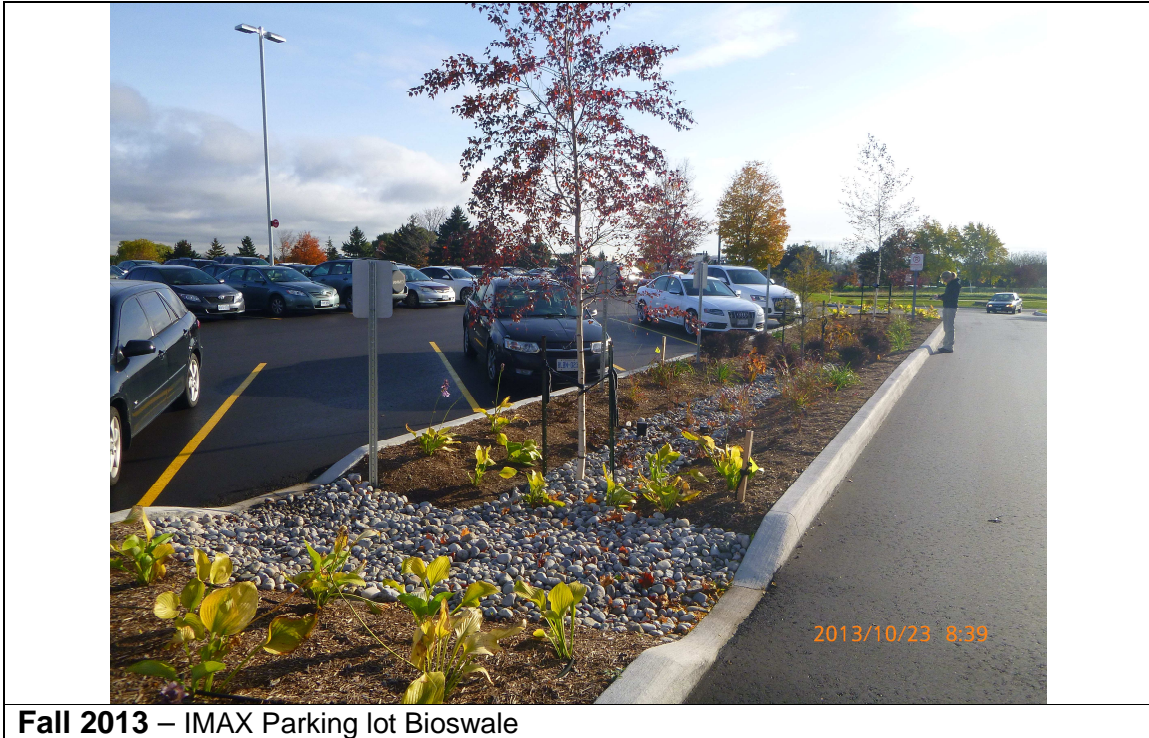
**Fall 2013** – IMAX Parking lot Bioswale

- **Landscaping** – Sod was applied to some sections of the IMAX site and others underwent hydroseeding and planting. The plants appear to be establishing well since planting.
- **Maintenance** – Site inspections have been completed four times so far to identify maintenance requirements and frequency. Since the site construction is now complete site inspections will take place monthly.
- **Water Levels** – Flows were observed from all stations during the largest rain event observed since monitoring equipment was installed (76 mm) with 5 days of nearly continuous rainfall.
- **Winter Monitoring** – Equipment will be removed from Area’s 5 and 6 for the winter months. Salt monitoring in the permeable pavement will be performed on Area 7 in the winter. Water level loggers in the shallow bioswale wells have been removed for the winter and will be replaced in the spring.
